SOUTH RESERVOIR DAM AND DIKES

MAIN DAM _____ MA 00453
EAST DIKE _____ MA 01278
WEST DIKE _____ MA 01279

PHASE I INSPECTION REPORT NATIONAL DAM INSPECTION PROGRAM

APRIL 1980

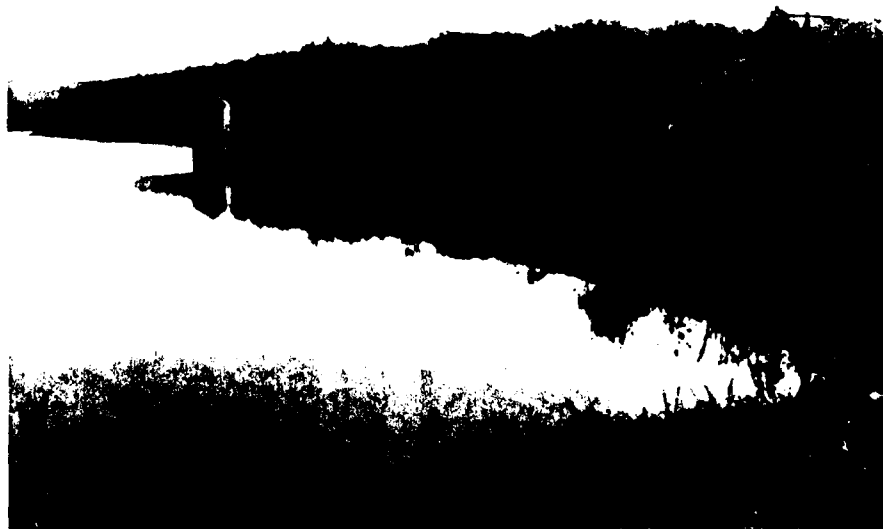
The upstream slope of the dam is inclined at about 1.5H:1V and is protected by riprap up to about 4 to 5 feet below the crest, as shown in photograph 4. The riprap is in good condition. The upper 4 to 5 feet of the upstream slope above the riprap is overgrown with brush, and a few small trees are growing on the slope. Minor erosion gullies were noted on the slope at both sides of the service bridge to the brick gatehouse which is located in the reservoir near the center of the dam.

PHOTO NO. 4 - Upstream face of Dam viewed from the spillway approach channel. Gatehouse can be seen in left center of photo. The crest of the Dam is used as an access road for gatehouse. Note riprap protection along face of Dam.

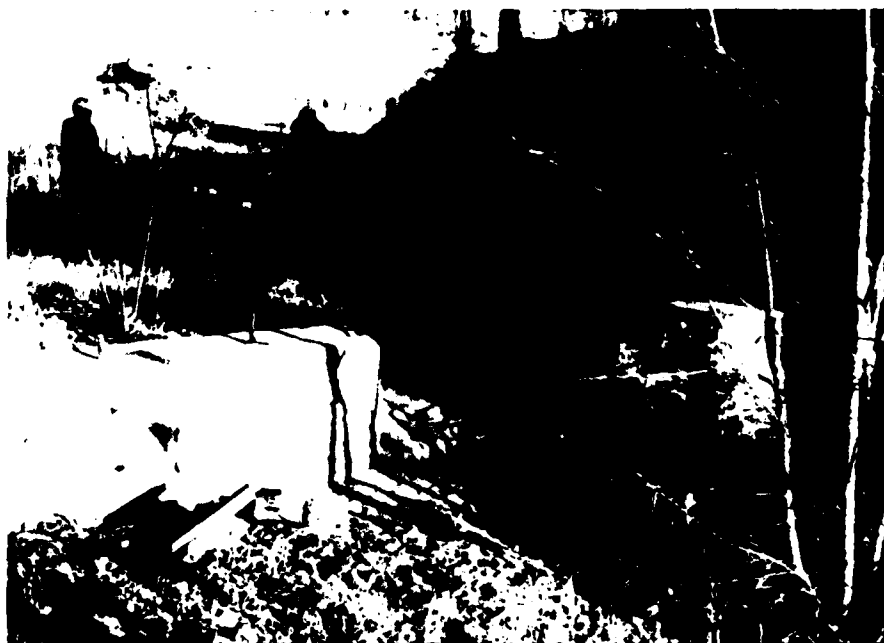
PHOTO NO. 2 - Spillway weir looking upstream.

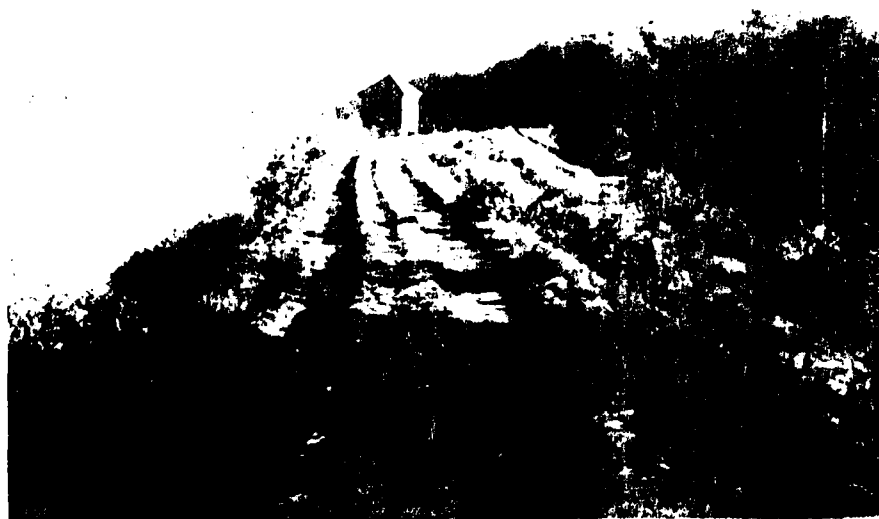
PHOTO NO. 6 - Upper portion of the downstream slope
of the Dam, looking left along the midslope berm.

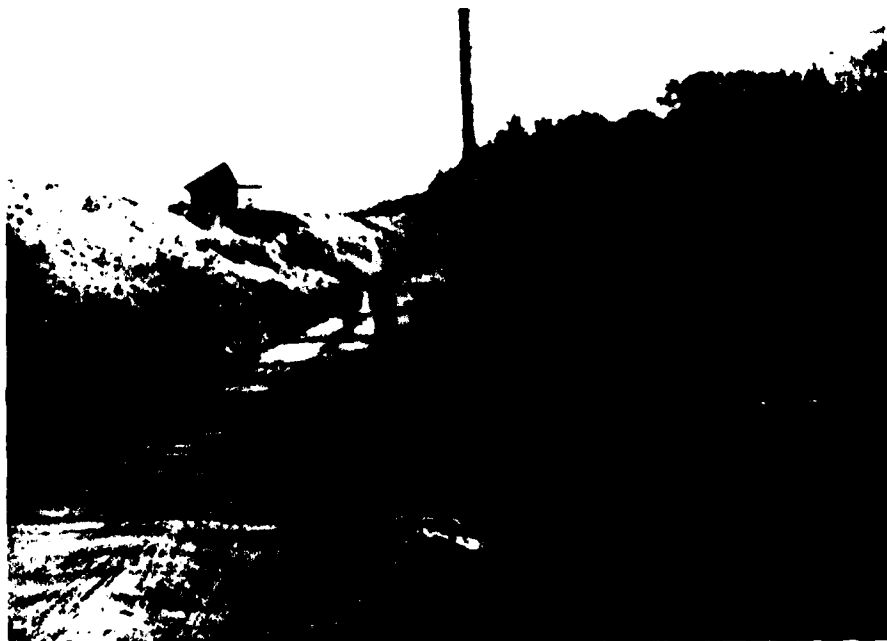
The downstream slope of the dam is separated into upper and lower portions by a midslope berm, as shown in photographs 12 and 14. The slope is inclined at 1.5H:1V. An unpaved access roadway runs along the midslope of the downstream slope, photograph 6, and a few small animal holes were observed on the slope. The lower portion of the downstream slope is heavily overgrown with brush, and a few small trees are growing on the slope, photographs 7 and 8. Much of the brush on the lower downstream slope consists of new growth from stumps of trees that have been cut in the past. Several minor erosion scarps and gullies (up to 2 to 3 feet wide and 6 to 12 inches deep) were noted on the lower downstream slope. No seepage was observed on the downstream side of the dam.

PHOTO NO. 12 - Downstream slope, looking left. Note
the configuration of the midslope berm separating
the upper and lower portions of the downstream
slope.

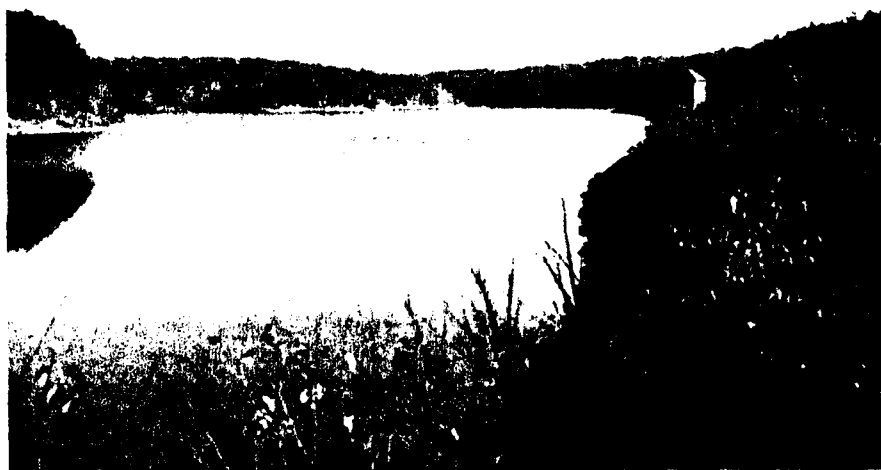
PHOTO NO. 13 - Reservoir viewed from Dam crest.
Gatehouse can be seen in right center of
photo. Tree cover around reservoir is
typical of drainage area.

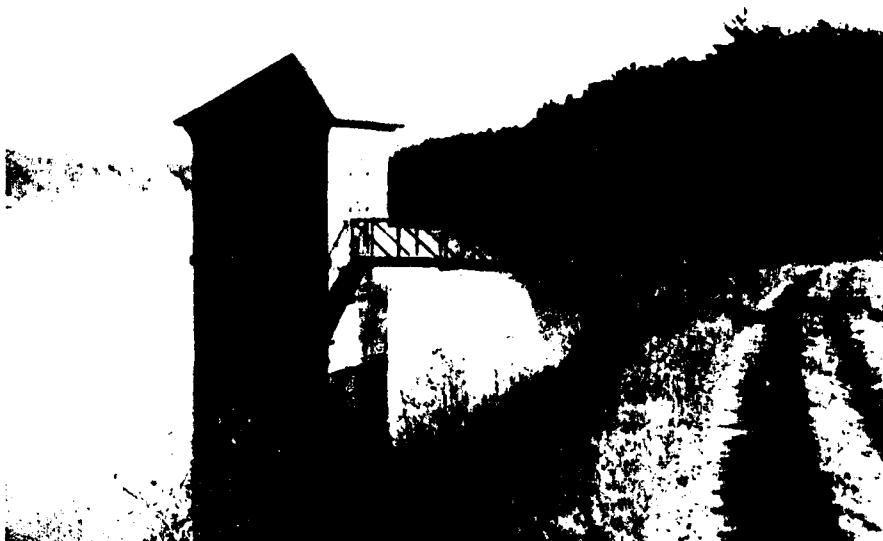
At the gatehouse, the control valve for the 30 inch waste line is kept closed. Its functionability is reported to be unknown. The valve for the 24 inch water supply line is always kept open and its operating condition is unknown.

PHOTO NO. 15 - View of the gatehouse. The gate house contains manually operated controls to allow the reservoir to discharge into either a 30 inch waste pipe or a 24 inch pipe on the town water supply system.

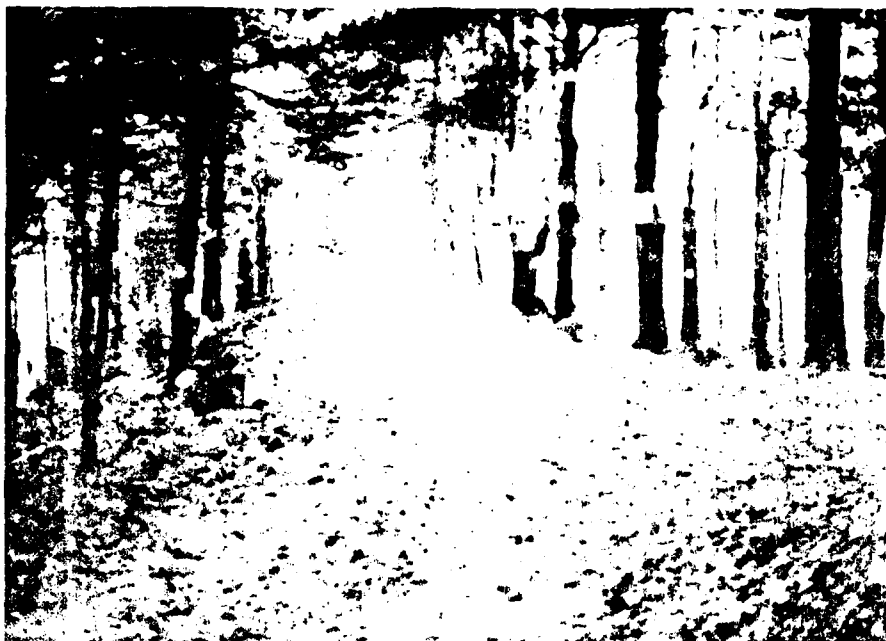
photograph 17. No evidence of cracking or misalignment was observed.

PHOTO NO. 17 - View of crest of west dike taken from left abutment.

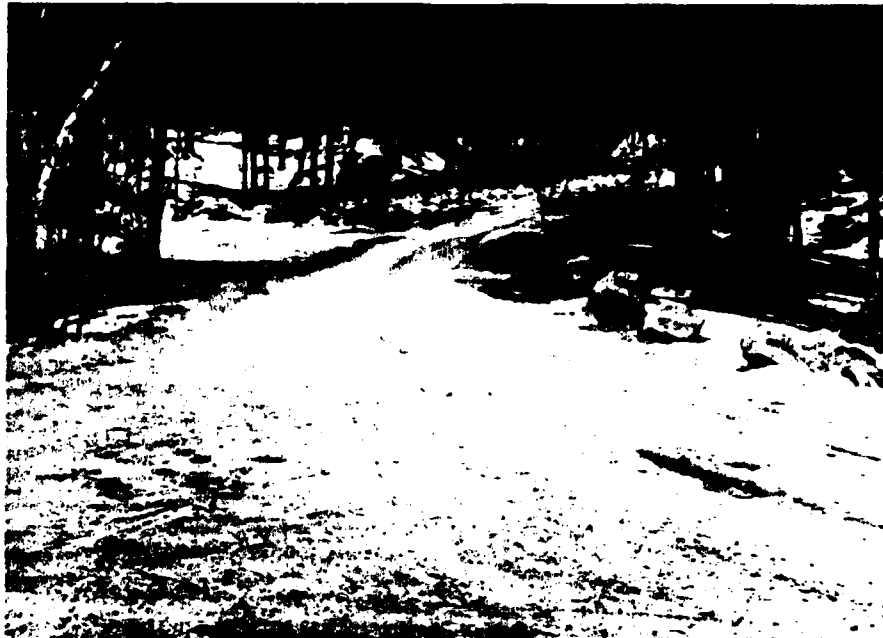
A dirt access road runs along the crest of the dike, as shown in photograph 19. No evidence of cracking or misalignment was observed.

PHOTO NO. 19 - Crest of the east dike, viewed from the
left abutment.
